User Safety Notice

ExtendAire™ I/II Emergency Breathing Supply Systems and RescueAire™ II Portable Air-Supply System

March 17, 2014

Male Quick Connect Fitting Replacement Program for ExtendAire™ I/II and RescueAire™ II Systems

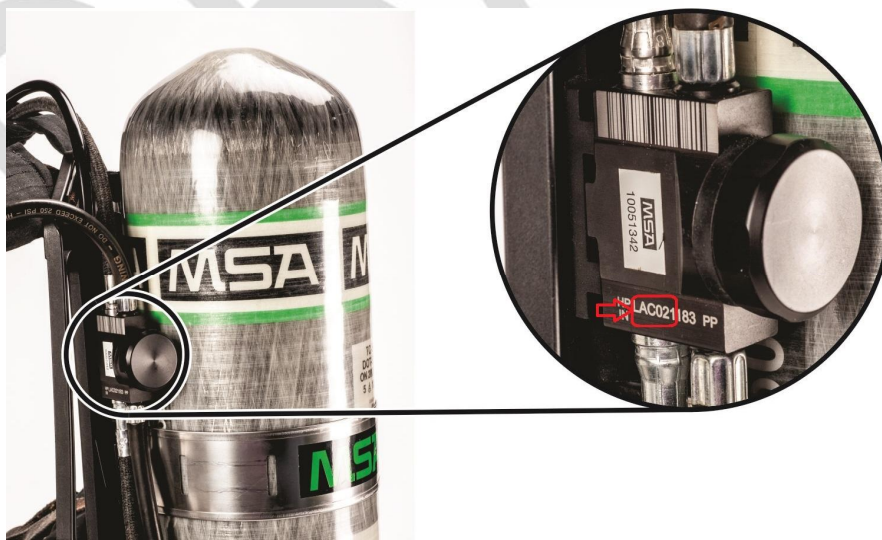
Air Mask Serial Number Location – Refer to First Six Digits

Affected air masks are equipped with an ExtendAire I or ExtendAire II System that have the first six digits of the first stage regulator serial number within the ranges listed below. Affected RescueAire II Systems have the first six digits of the first stage regulator serial number within the ranges listed below.
